AFRL-ML-WP-TR-2000-4154

EFFECT OF SURFACE PREPARATION ON FATIGUE DURABILITY OF BONDED COMPOSITE REPAIR PATCHES VOLUME 6 – DELIVERY ORDER 4, TASK 1

D. Robert Askins University of Dayton Research Institute 300 College Park Avenue Dayton, OH 45469-0130

FINAL REPORT FOR PERIOD 01 MAY 1998 - 30 AUGUST 1999

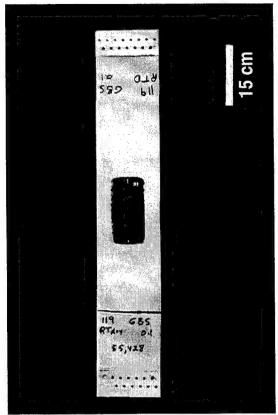
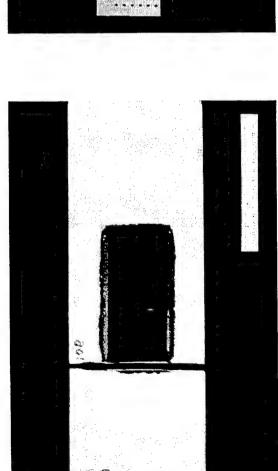
Figure 9. Noninterfacial Failure Modes Observed on Fatigue Specimens

- (a) Fracture of the aluminum substrate panel through the boltholes in the gripping area on the end of the specimen. This occurred on approximately 40% of the specimens. On nearly every one of these specimens interfacial debonding of the patch from the substrate aluminum panel also occurred and had been developing well before the bolthole fracture occurred. Where this type of failure occurred, and a more significant debonding mode of failure could not be attributed, it is designated as (G).

- (b) Fracture of the aluminum substrate panel away from both the grip region and the patch region is designated as (M_a) .
- (c) Fracture of the aluminum substrate panel immediately adjacent to the end of the composite patch is designated as (M_e).

Metal Fracture Away from Patch, Ma

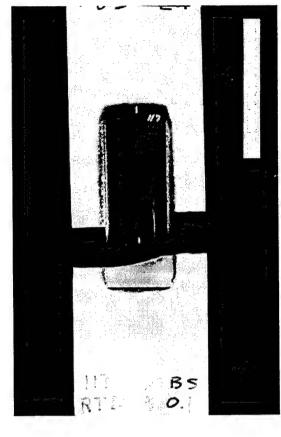
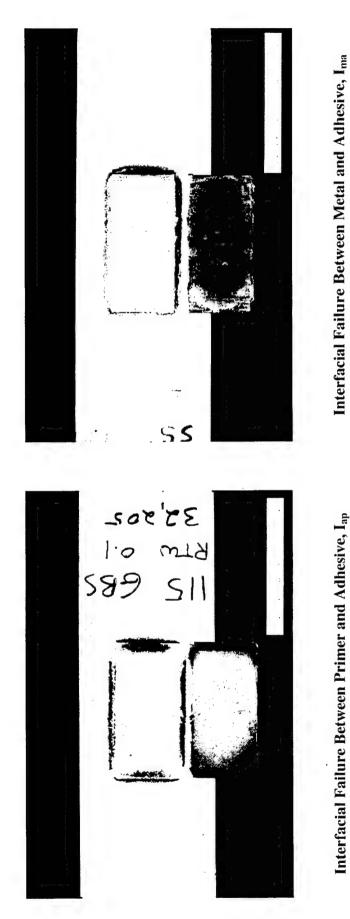
Figure 10. Interfacial Failure Modes Observed in Fatigue Tests

- (d) Fracture of the aluminum substrate panel into two halves while the patch remains essentially intact on one or the other specimen halves. In this case the fracture of the metal under the patch is designated as (Mu). This failure mode also requires an identification of the failure locus where the patch pulled off the aluminum. In every case, it was one of the following three modes:

- 1. Cohesive failure within the adhesive layer is designated as (C).
 - 2. Interfacial failure between the adhesive and the primer is designated as (I_{AP}) .

- 3. Interfacial failure between the adhesive and the unprimed metal is designated as (I_{AM}) .

Metal Fracture Under Patch, M_u Cohesive Failure in Adhesive, C

Metal Fracture at End of Patch, Me

Interfacial Failure Between Metal and Adhesive, Ima

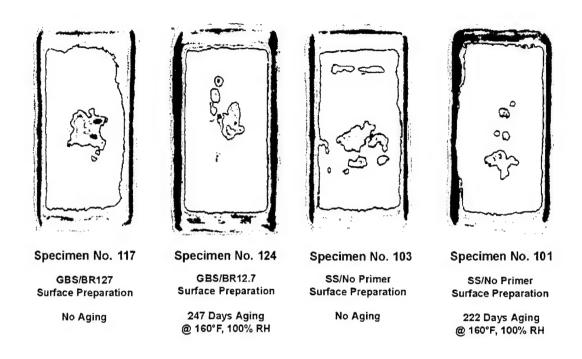
Figure 19. Effect of Wet-Aging on Bondline Integrity as Indicated by C-Scans

In order to quantify changes in the appearance of the C-scans as load cycles accumulated, the percent of the patch area that exhibited a signal attenuation of 50 percent or less, relative to the lowest attenuation level for a well-bonded patch, was measured and recorded at each inspection interval. Figures 20 through 23 illustrate the C-scans for several typical specimens as fatigue load cycles accumulated and illustrate the progressive degradation of the bondline. As described in Section 4.1, it must be kept in mind that although these figures are presented in black/white/shades-of-gray, the original C-scans were in color. The signal attenuation levels at various locations in the bondlines are much more readily discerned on the colored originals than on the black/white/shades-of-gray copies incorporated into this report. For the C-scans in Figures 20 through 23, the portion of each bondline that remains undegraded is outlined by a black tracing and labeled G, where the G signifies this area is still as good as it appeared on the initial C-scan before load cycling started.

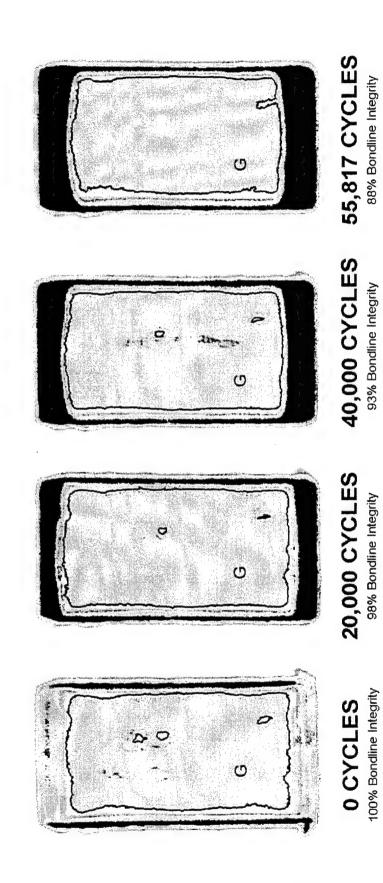
Figure 20. Effect of Fatigue Cycling on Bondline Integrity as Indicated by C-Scans

Specimen No.: 127
Surface Preparation: Grit-Blast Silane/BR127
Test Condition: Room Temperature Dry
Fatigue Stress Ratio: 0.1

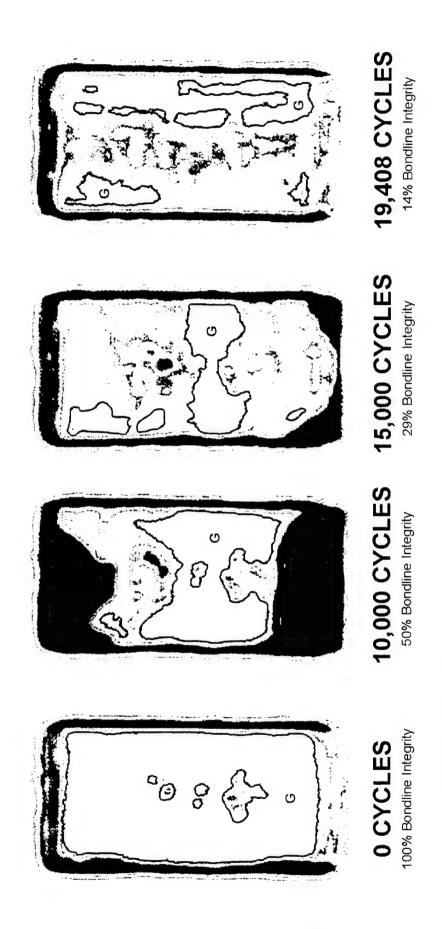
Figure 23. Effect of Fatigue Cycling on Bondline Integrity as Indicated by C-Scans

Surface Preparation: Scuff-Sand/No Primer

Test Condition: Room Temperature Wet

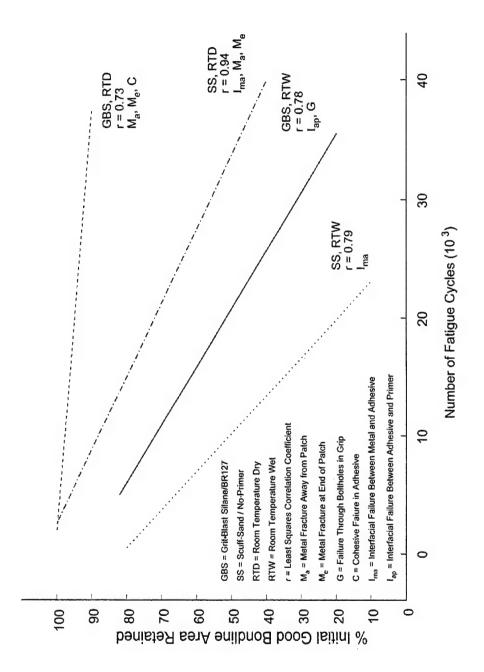
Figure 24. Effect of Fatigue Cycling on Bondline Integrity of Patched Specimens Tested at Room Temperature and at a Stress Ratio of 0.1

Figure 24 shows that while the bondlines of the GBS/BR127 specimens exhibited 10 percent loss of overall integrity after 40,000 fatigue cycles, the SS specimens lost 60 percent of their overall integrity after 40,000 fatigue cycles. This disparity is supported by a difference in failure mode. The GBS/BR127 specimens failed predominantly in the metal outside the patch area with the patches remaining firmly bonded to the aluminum. Four of the five SS specimens also exhibited failure in the metal but it was accompanied by visible disbonding of the patches on at least one end. Removal of these patches revealed that the loss of bond integrity evident in the C-scans was due to interfacial failure between the adhesive and the aluminum. For this test condition, the GBS/BR127 surface preparation is clearly more durable than the SS surface preparation.

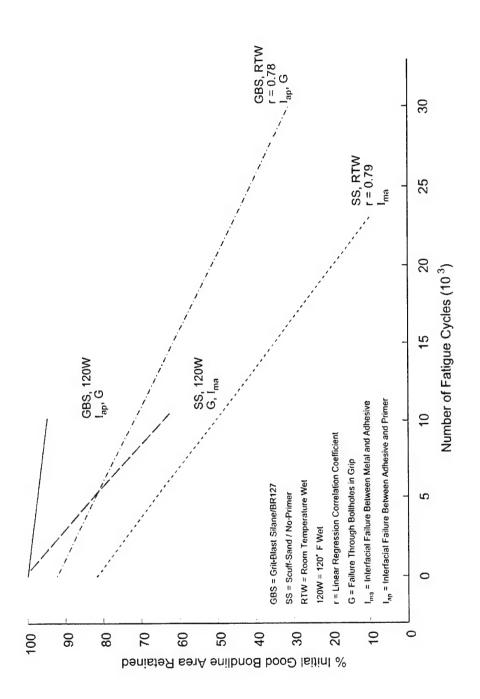
Figure 25. Effect of Fatigue Cycling on Bondline Integrity of Patched Specimens Tested in the Wet Condition and at a Stress Ratio of 0.1

There are six combinations of test conditions for which the two different surface preparations used in this investigation can be compared. These include two test temperatures (room temperature and 120 °F), two aging conditions (dry and wet), and two cyclic stress ratios (0.1 and 0.5). Figures 24 through 28 illustrate the comparative resistance of these two surface preparations to degradation during fatigue cycling. Each of these figures plots the bondline integrity (ratio of remaining good bond area to original good bond area, as determined from C-scans) versus the number of fatigue cycles. The following paragraphs each focus on a single combination of test parameters and compare the behavior of the GBS/BR127 surface preparation to the SS/no-primer surface preparation. It will become apparent that the GBS/BR127 surface preparation proves to be consistently superior, as would be expected.
